PRIMARY RECORD

* Resource Name or #: Tract 616

* P11. Report Citation: (Cite survey report/other sources or "none") The Interstate 405 Improvement Project from State Route 73 to Interstate 605 in Orange County, California Project Historical Resources Evaluation Report

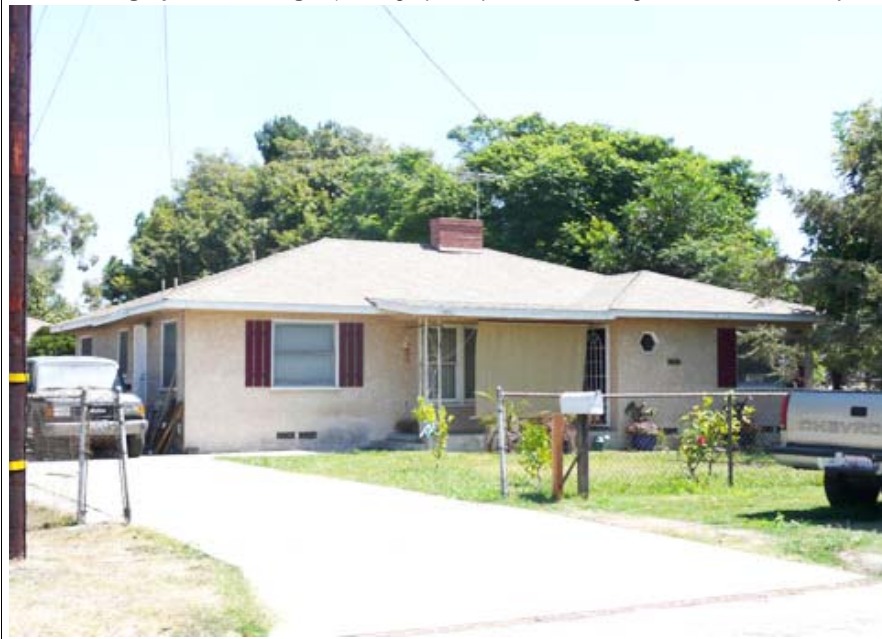
* P3a. Description: (Describe resource and its major elements. Include design, materials, condition, alterations, size, setting, and boundaries.)
Of the 22 parcels of Tract 3995 that are located within the APE, three contained buildings with sufficient integrity to warrant further investigation, which resulted in the subdivision retaining 14 percent integrity. None of the three buildings appear to possess sufficient architectural quality for the reasons identified in the district record to be considered eligible for listing in the NRHP or the CRHR as individual historic resources or as a historic district.

View of a common Ranch style building found in this district.

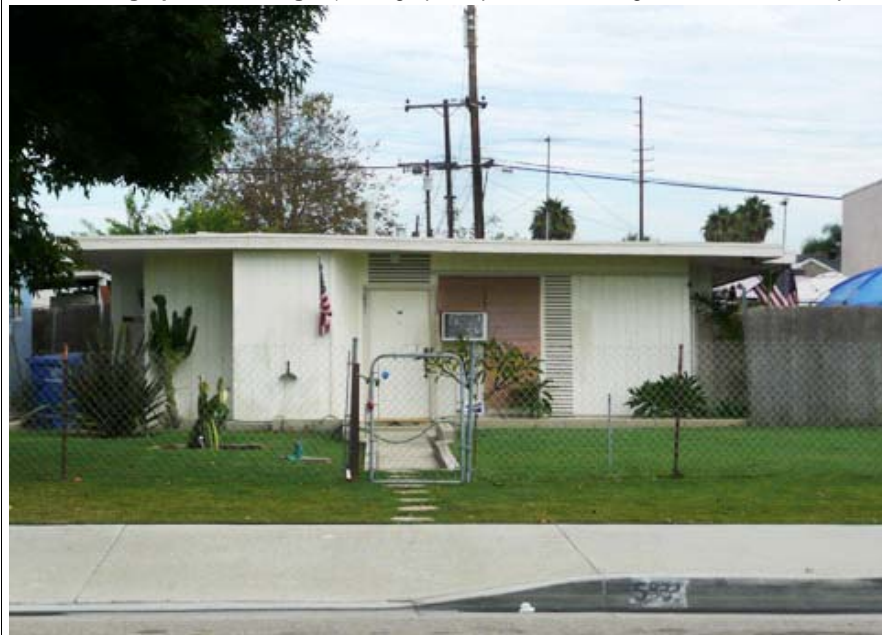
Facing north; 9/29/2010; Photo No.

* P3a. Description: (Describe resource and its major elements. Include design, materials, condition, alterations, size, setting, and boundaries.)
The one-story Ranch style building is rectangular in plan. The flat roof, with boxed eaves, is clad in an unknown material. The exterior walls are clad in vertical wood siding. Wood louvers and curtains cover the windows, and further details were not visible from the public right of way. The primary entrance is raised, and accessed via a cast concrete porch. The building does not meet the NRHP and CRHR eligibility criteria for the reasons identified on the district record prepared for this subdivision; therefore the building does not contribute to a historic district and is not individually eligible for listing in the NRHP and the CRHR.

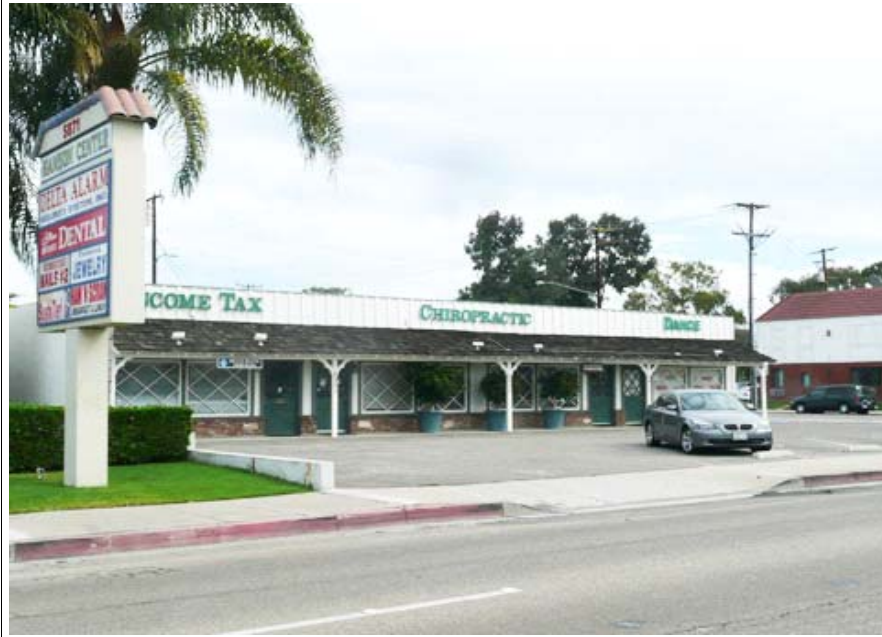
Facing northeast; 9/29/2010; Photo No.

* P3a. Description: (Describe resource and its major elements. Include design, materials, condition, alterations, size, setting, and boundaries.)
The one-story Ranch style commercial building is rectangular in plan. The flat roof, with board and batten clad parapet wall, is clad in composition roll. A pent roof, clad in wood shingles, with exposed rounded rafter tails, and supported by square wood posts with decorative brackets, spans primary façade. The exterior walls are clad in smooth textured stucco with brick veneer to the water line. The diamond-paned fixed-pane storefront windows and wood with diamond-pane glazing storefront doors appear to be original. The building does not meet the NRHP and CRHR eligibility criteria for the reasons identified on the district record prepared for this subdivision; therefore the building does not contribute to a historic district and is not individually eligible for listing in the NRHP and the CRHR.

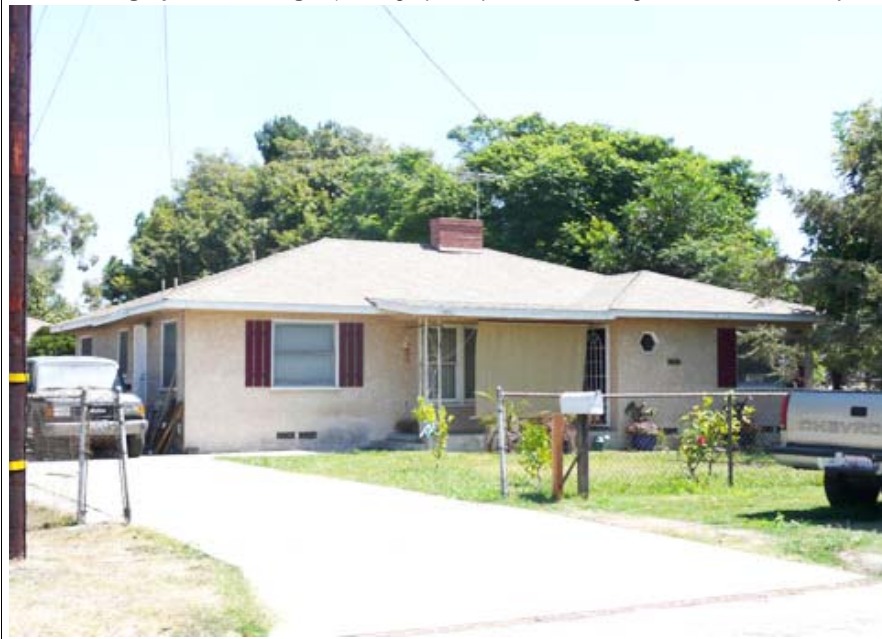
Facing east; 9/1/2010; Photo No.

* P3a. Description: (Describe resource and its major elements. Include design, materials, condition, alterations, size, setting, and boundaries.)
The one-story Ranch style building is 'L'-shaped in plan. The cross hip and pyramidal roof is clad in composition shingles. A brick chimney is located at the roof crest. The exterior walls are clad in rough texture stucco. The one-over-one wood sash windows appear to be original and are accented with shutters. It is not known if the octagonal window is original to the building. The primary entrance is raised, and accessed via a cast concrete porch. The roof overhangs to shelter the primary entry porch, and is supported by decorative metal columns. A detached garage is located in the rear of parcel. The building does not meet the NRHP and CRHR eligibility criteria for the reasons identified on the district record prepared for this subdivision; therefore the building does not contribute to a historic district and is not individually eligible for listing in the NRHP and the CRHR.

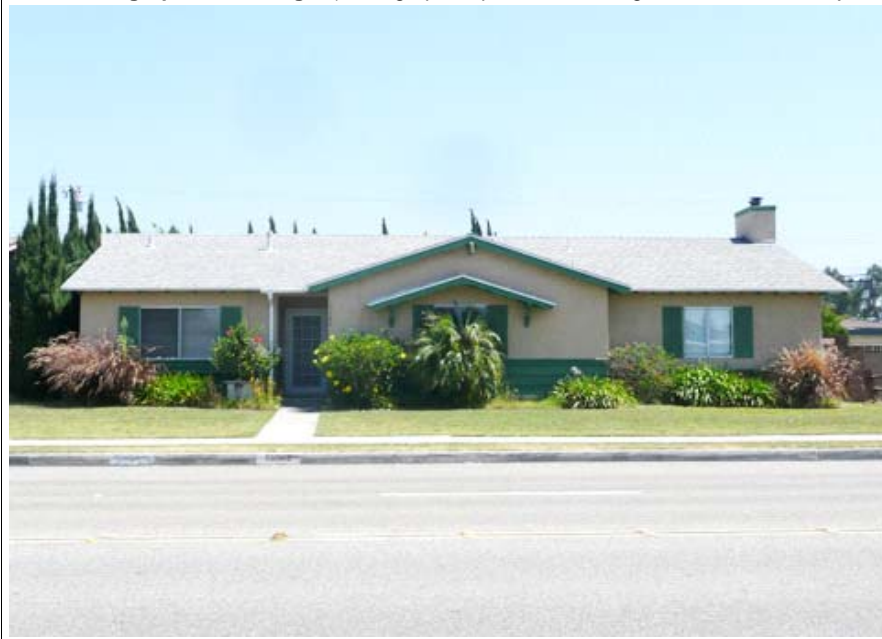
* P3a. Description: (Describe resource and its major elements. Include design, materials, condition, alterations, size, setting, and boundaries.)
Of the 47 parcels of the tracts that are located within the APE, 11 contained buildings with sufficient integrity to warrant further investigation, which resulted in the subdivision retaining 23 percent integrity. None of the six buildings appear to possess sufficient architectural quality for the reasons identified in the district record to be considered eligible for listing in the NRHP or the CRHR as individual historic resources or as a historic district.

View of a common Ranch style building found in this district.

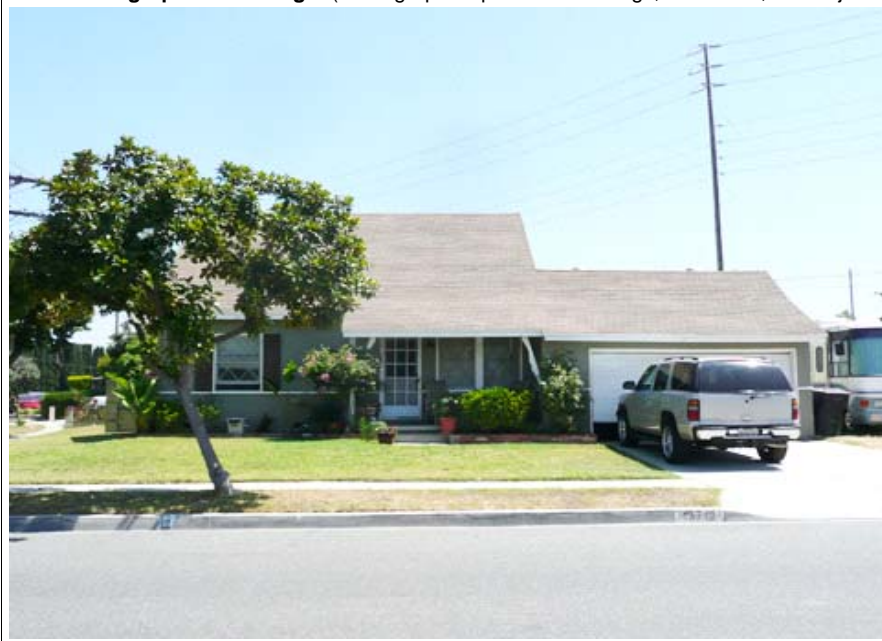
Facing east; 9/1/2010; Photo No.

* P3a. Description: (Describe resource and its major elements. Include design, materials, condition, alterations, size, setting, and boundaries.)
The one-story Ranch style building is generally rectangular in plan. The side gabled roof, with flared eaves, is clad in composition shingles. The exterior walls are clad in smooth textured stucco, and are accented with a band board at the water line. The diamond-paned sash windows appear to be original. The primary entrance is raised, and accessed via a cast concrete porch. The roof overhangs to shelter the primary entry porch and is supported by square wood posts with decorative brackets. The building does not meet the NRHP and CRHR eligibility criteria for the reasons identified on the district record prepared for this subdivision; therefore the building does not contribute to a historic district and is not individually eligible for listing in the NRHP and the CRHR.

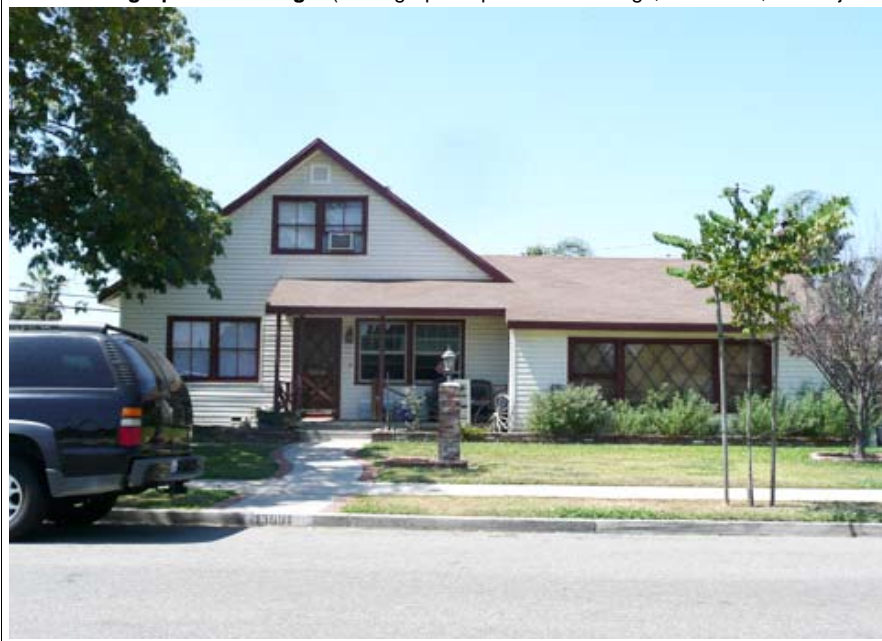
Facing west; 9/1/2010; Photo No.

* P3a. Description: (Describe resource and its major elements. Include design, materials, condition, alterations, size, setting, and boundaries.)
The 1 1/2-story Ranch style building is irregular plan. The cross gable roof, with boxed eaves, is clad in composition shingles. A brick chimney is located on the northern façade. The exterior walls are clad in vinyl siding, and it is not known if the original siding is extant. Two of the windows have been replaced with vinyl sash units, and the remaining windows are two-over-two wood sash, diamond-paned sash, and fixed-pane windows. The primary entrance is raised, and accessed via a cast concrete porch. The roof extends to shelters the primary entryway, and is supported by square posts. A low porch railing with diamond-patterned wood bracing partially encloses the porch. The building does not meet the NRHP and CRHR eligibility criteria for the reasons identified on the district record prepared for this subdivision; therefore the building does not contribute to a historic district and is not individually eligible for listing in the NRHP and the CRHR.

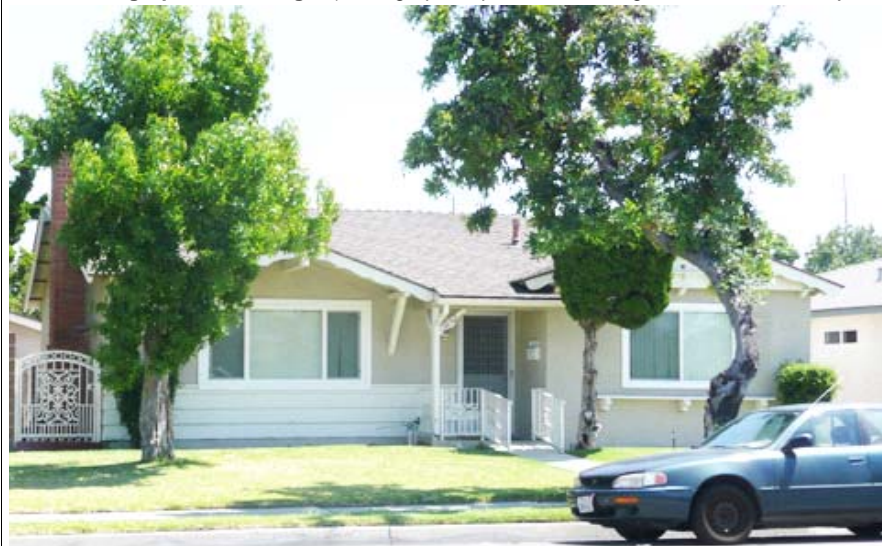
Facing east; 9/1/2010; Photo No.

* P3a. Description: (Describe resource and its major elements. Include design, materials, condition, alterations, size, setting, and boundaries.)
The one-story Ranch style building is 'L'-shaped in plan. The cross gabled roof is clad in composition shingles. The front facing gables are accented with scalloped barge board, brackets, and false beams. The southerly bay is further accented with a dove-cote and a flower-box ledge with brackets. A brick chimney is located on north façade. The exterior walls are clad in smooth textured stucco, and horizontal wood siding. The windows have been replaced with vinyl sliding and fixed-pane units. The primary entrance is raised, recessed, and accessed via a cast concrete porch with decorative metal railing. The building does not meet the NRHP and CRHR eligibility criteria for the reasons identified on the district record prepared for this subdivision; therefore the building does not contribute to a historic district and is not individually eligible for listing in the NRHP and the CRHR.

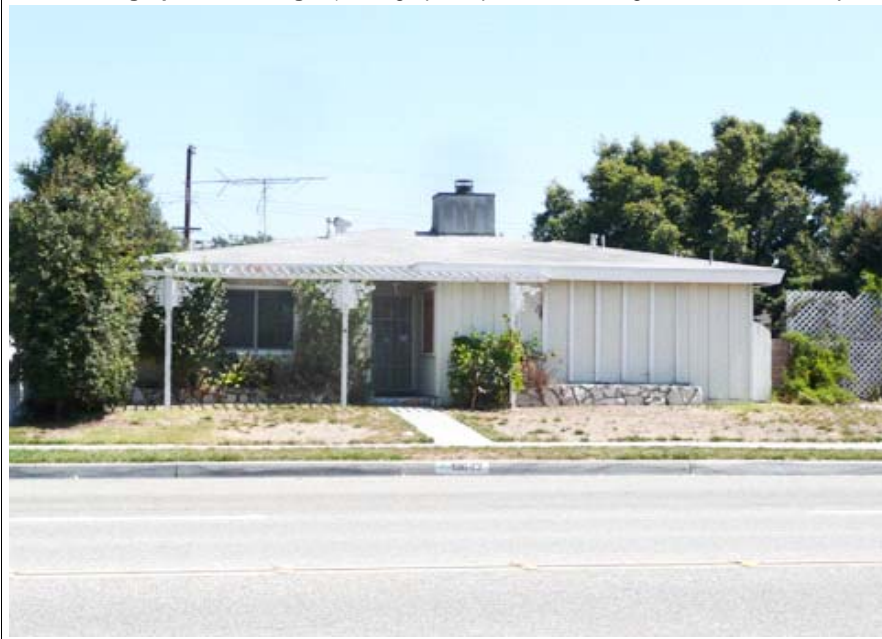
Facing east; 9/1/2010; Photo No.

* P3a. Description: (Describe resource and its major elements. Include design, materials, condition, alterations, size, setting, and boundaries.)
The one-story Ranch style building is generally square in plan. The cross hip and pyramidal roof, with boxed eaves, is clad in composition shingles. A swamp cooler has been installed on the west face of the roof. The exterior walls are clad in vertical wood siding and smooth textured stucco with batten. The aluminum sliding windows appear to be original, and one window has been boarded up. The primary entrance is raised, recessed, and accessed via a cast concrete porch. A trellis with decorative brackets was attached to the building at an unknown date, and other landscaping elements include stone planters. The building does not meet the NRHP and CRHR eligibility criteria for the reasons identified on the district record prepared for this subdivision; therefore the building does not contribute to a historic district and is not individually eligible for listing in the NRHP and the CRHR.

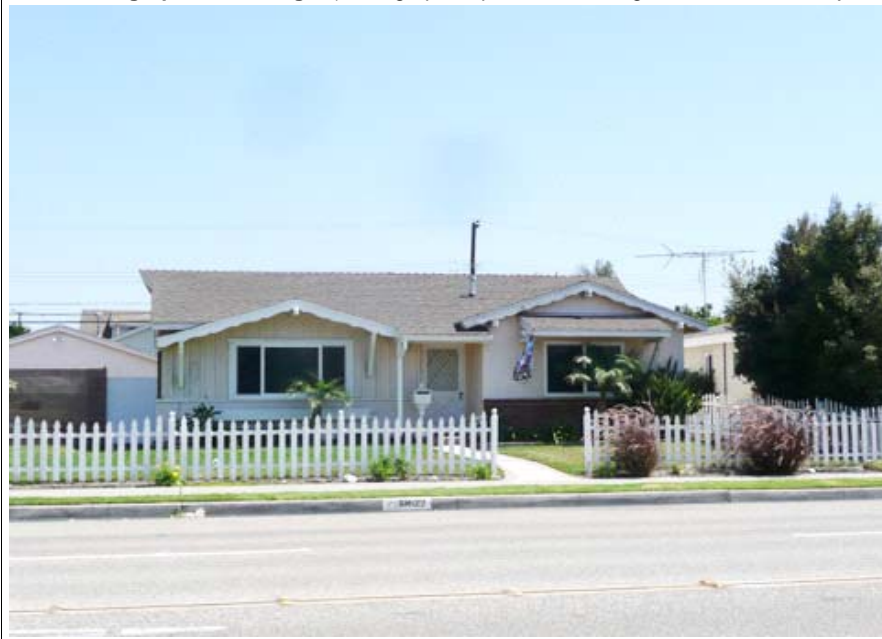
Facing east; 9/1/2010; Photo No.

* P3a. Description: (Describe resource and its major elements. Include design, materials, condition, alterations, size, setting, and boundaries.)
The one-story Ranch style building is square in plan. The cross gabled roof, with boxed eaves and flared gable heads, is clad in composition shingles. The front facing gables are accented with scalloped barge board, false beams, and brackets. The exterior walls are clad in smooth textured stucco, and are accented with a band board at the water line. The southerly bay of the primary (western) façade is accented with brick veneer to the water line, and the northerly bay is accented with board and batten siding above the water line. The windows have been replaced with vinyl sliding and fixed-pane units. The primary entrance is recessed and accessed via a tile-clad porch. The roof overhangs to shelter the primary entrance porch, and is supported by a wood post with a decorative bracket. A detached garage is located in the rear of parcel. The building does not meet the NRHP and CRHR eligibility criteria for the reasons identified on the district record prepared for this subdivision; therefore the building does not contribute to a historic district and is not individually eligible for listing in the NRHP and the CRHR.

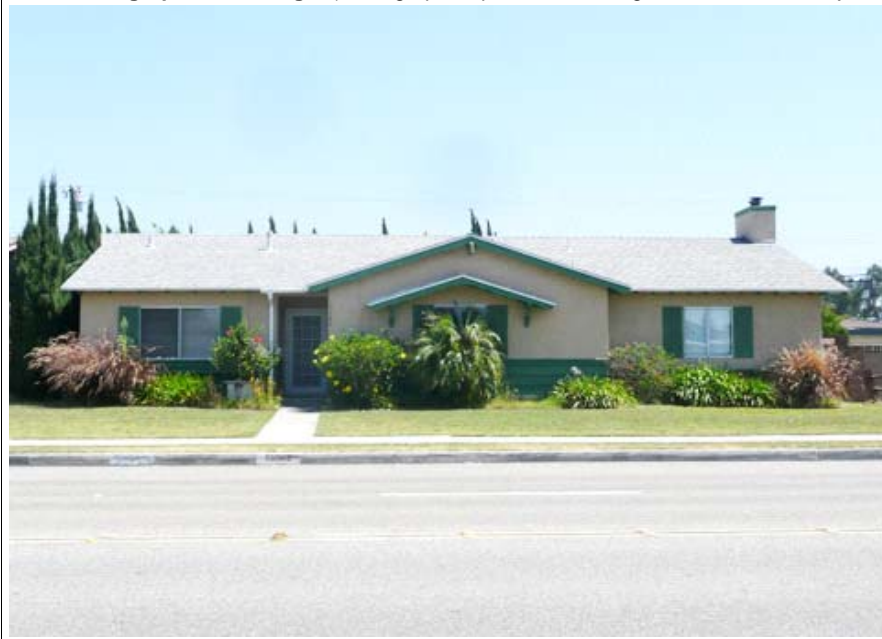
Facing east; 9/1/2010; Photo No.

* P3a. Description: (Describe resource and its major elements. Include design, materials, condition, alterations, size, setting, and boundaries.)
The one-story Ranch style building is rectangular plan. The cross gabled roof is clad in composition shingles, and is accented with exposed rafter tails. The northerly gable head is flared. The front gables are accented with scalloped barge board, a false beam, and brackets. A stucco clad chimney is centrally located on the southern façade. The exterior walls are clad in smooth textured stucco with horizontal wood siding to the water line. The aluminum sliding units appear to be original and are accented with shutters. The primary entrance is recessed, raised, and accessed via a cast concrete porch. The building does not meet the NRHP and CRHR eligibility criteria for the reasons identified on the district record prepared for this subdivision; therefore the building does not contribute to a historic district and is not individually eligible for listing in the NRHP and the CRHR.

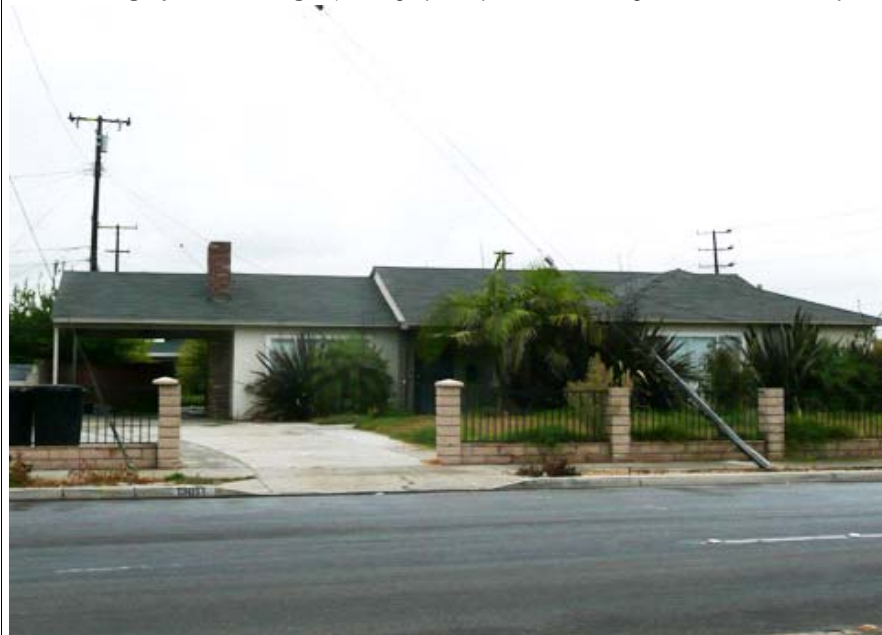
Facing west; 10/5/2010; Photo No.

* P3a. Description: (Describe resource and its major elements. Include design, materials, condition, alterations, size, setting, and boundaries.)
The one-story Ranch style building is 'L'-shaped in plan. The side gable/hipped roof, with boxed eaves, is clad in composition shingles. A brick chimney is located on the south end of the east face of the roof. The exterior walls are clad in smooth textured stucco. The windows have been replaced with vinyl sliding and fixed-pane units. The primary entrance is raised, and accessed via a cast concrete porch. The roof overhangs to shelter the primary entry porch, and is supported by a decorative metal column. The building does not meet the NRHP and CRHR eligibility criteria for the reasons identified on the district record prepared for this subdivision; therefore the building does not contribute to a historic district and is not individually eligible for listing in the NRHP and the CRHR.

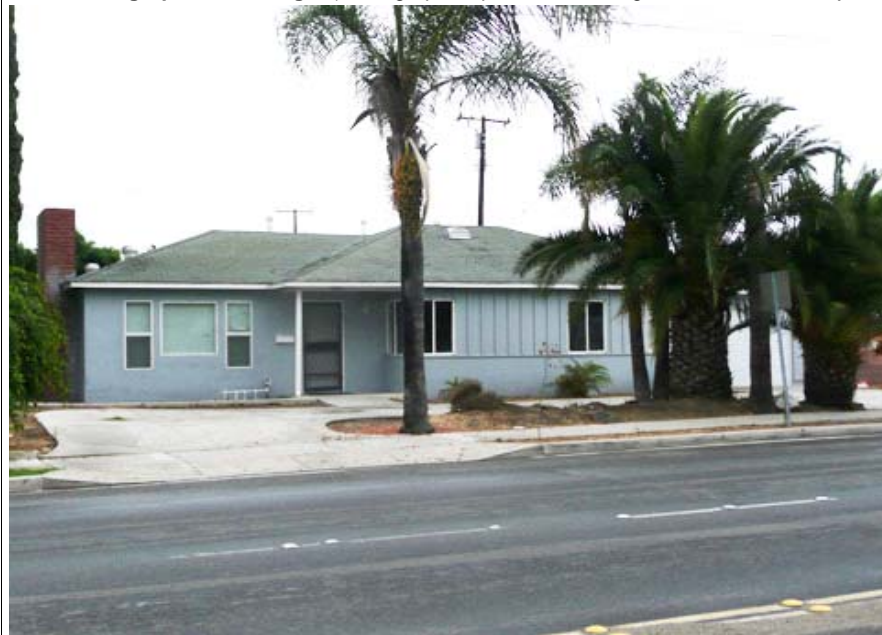
Facing west; 10/5/2010; Photo No.

* P3a. Description: (Describe resource and its major elements. Include design, materials, condition, alterations, size, setting, and boundaries.)
The one-story Ranch style building is irregular in plan. The cross hipped roof, with boxed eaves, is clad in composition shingles. A brick chimney is located on the southern façade. The exterior walls are clad in smooth textured stucco and board and batten siding with smooth textured stucco to the water line. The windows have been replaced with vinyl sliding, sash, and fixed-pane units. The primary entrance is raised and accessed via a cast concrete porch. The roof overhangs to shelter the primary entryway way, and is supported by a square wood post. The building does not meet the NRHP and CRHR eligibility criteria for the reasons identified on the district record prepared for this subdivision; therefore the building does not contribute to a historic district and is not individually eligible for listing in the NRHP and the CRHR.

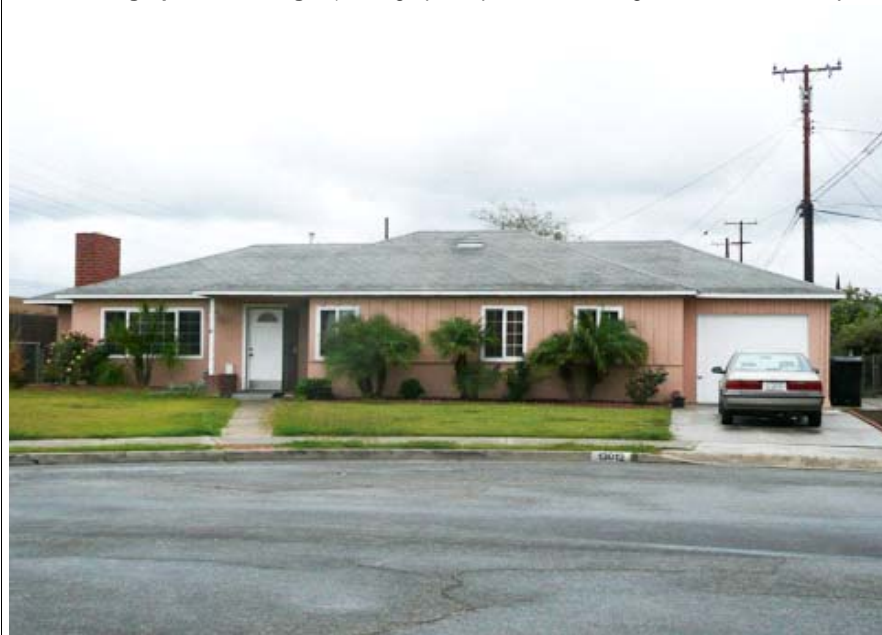
Facing east; 10/5/2010; Photo No.

* P3a. Description: (Describe resource and its major elements. Include design, materials, condition, alterations, size, setting, and boundaries.)
The one-story Ranch style building is irregular in plan. The cross hipped roof, with boxed eaves, is clad in composition shingles. A brick chimney is located on the north façade. The exterior walls are clad in smooth textured stucco and board and batten siding with smooth textured stucco to the water line. The windows have been replaced with vinyl sliding and fixed-pane units, and are accented with wood surrounds. The primary entrance is raised, and accessed via a cast concrete porch. A low brick wall with square wood post supports the roof which overhangs to shelter the primary entryway. The building does not meet the NRHP and CRHR eligibility criteria for the reasons identified on the district record prepared for this subdivision; therefore the building does not contribute to a historic district and is not individually eligible for listing in the NRHP and the CRHR.

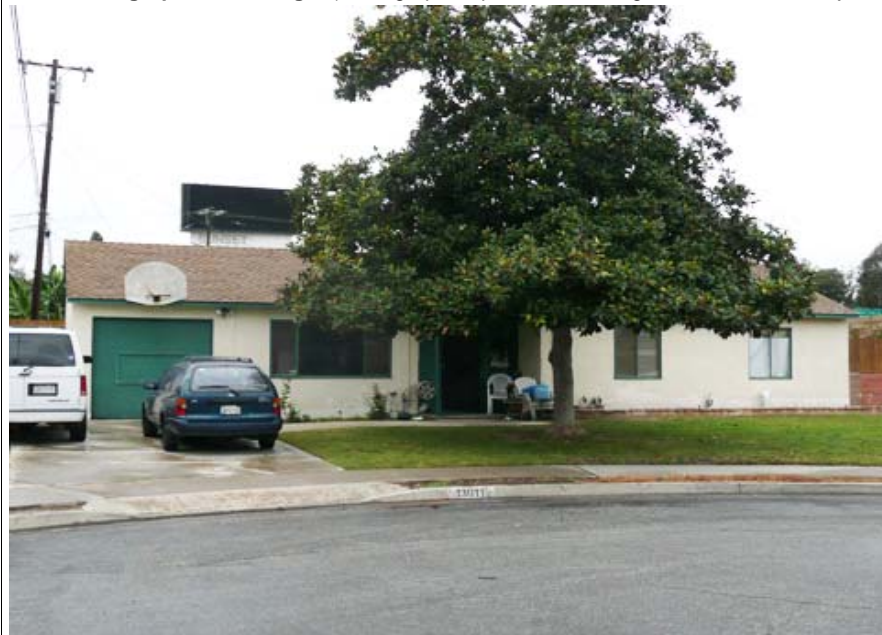
Facing west; 10/5/2010; Photo No.

* P3a. Description: (Describe resource and its major elements. Include design, materials, condition, alterations, size, setting, and boundaries.)
The one-story Ranch style building is rectangular in plan. The side gabled roof is clad in composition shingles. The exterior walls are clad in smooth textured stucco, which is in poor condition. The aluminum sliding and fixed-pane windows appear to be original. The primary entrance is recessed, and is accessed via a cast concrete porch. The roof overhangs to shelter the primary entryway, and is supported by a square wood post. The attached one-car garage retains its original wood pivot door with geometric detailing. The building does not meet the NRHP and CRHR eligibility criteria for the reasons identified on the district record prepared for this subdivision; therefore the building does not contribute to a historic district and is not individually eligible for listing in the NRHP and the CRHR.

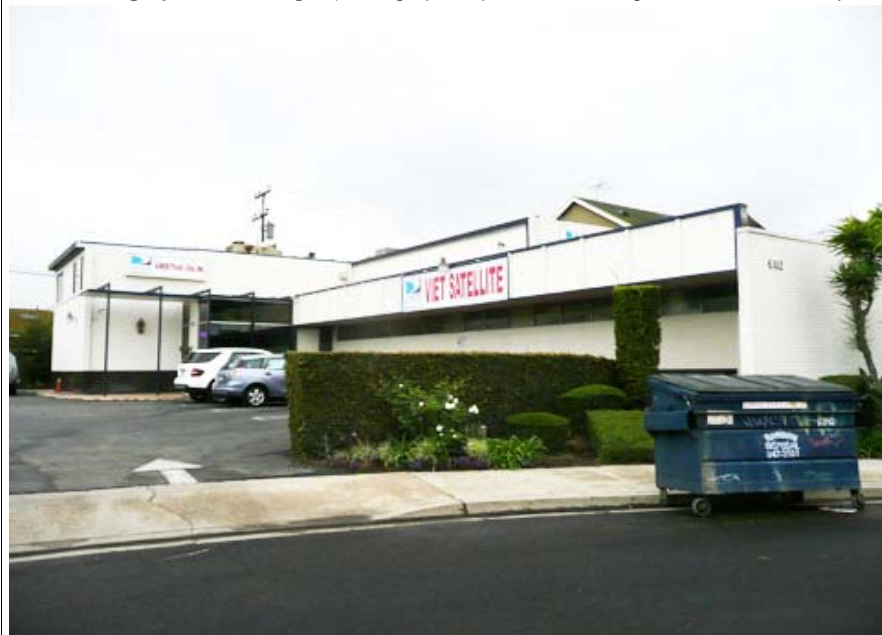
Facing southwest; 10/5/2010; Photo No.
P1040857.jpg

* P3a. Description: (Describe resource and its major elements. Include design, materials, condition, alterations, size, setting, and boundaries.)
The one- and two-story building is 'L'-shaped in plan. The flat roof, with parapet wall, is clad in composition roll. The parapet wall is clad in board and batten siding. The exterior walls are clad in smooth textured stucco, diagonal wood siding, and brick veneer. The one-story bay of the building has a ribbon of aluminum fixed-pane window at the eave of the primary (eastern) façade. The two-story bay of the building is accessed via a glass-enclosed atrium area, and it is not known if this is original to the building. External L-beams accent the entry on this bay, and support a slab which shelters the walkway leading to the primary entrance. The building does not meet the NRHP and CRHR eligibility criteria for the reasons identified on the district record prepared for this subdivision; therefore the building does not contribute to a historic district and is not individually eligible for listing in the NRHP and the CRHR.

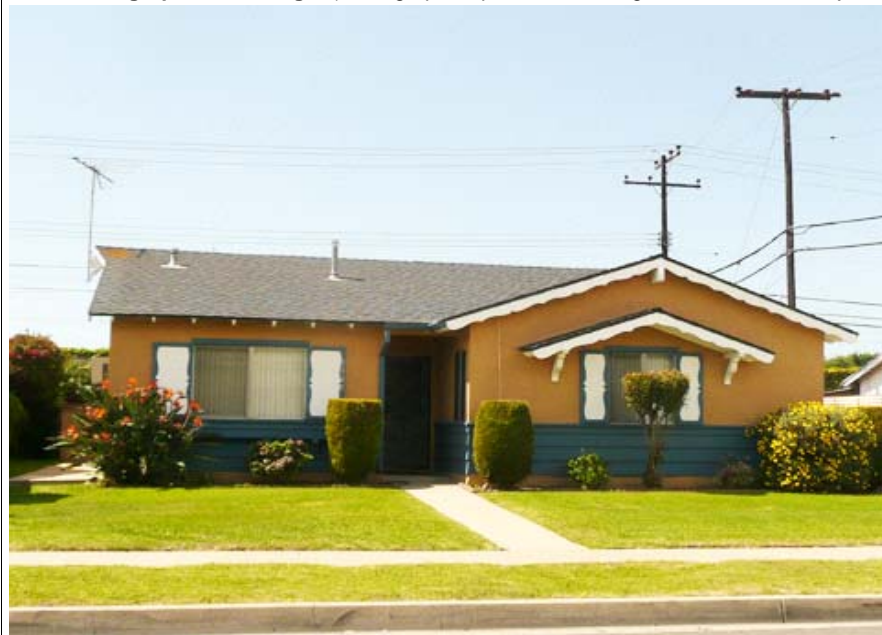
* P3a. Description: (Describe resource and its major elements. Include design, materials, condition, alterations, size, setting, and boundaries.)
Of the 64 parcels of the tract located within the APE, only fourteen possessed sufficient integrity to warrant further investigation, which resulted in the subdivision retaining 22 percent integrity. None of the fourteen buildings intensively surveyed for this project appear to possess sufficient architectural quality for the reasons identified in the district record to be considered eligible for listing in the NRHP or the CRHR either individually or as a historic district.

View of a common style of Ranch found in the district.

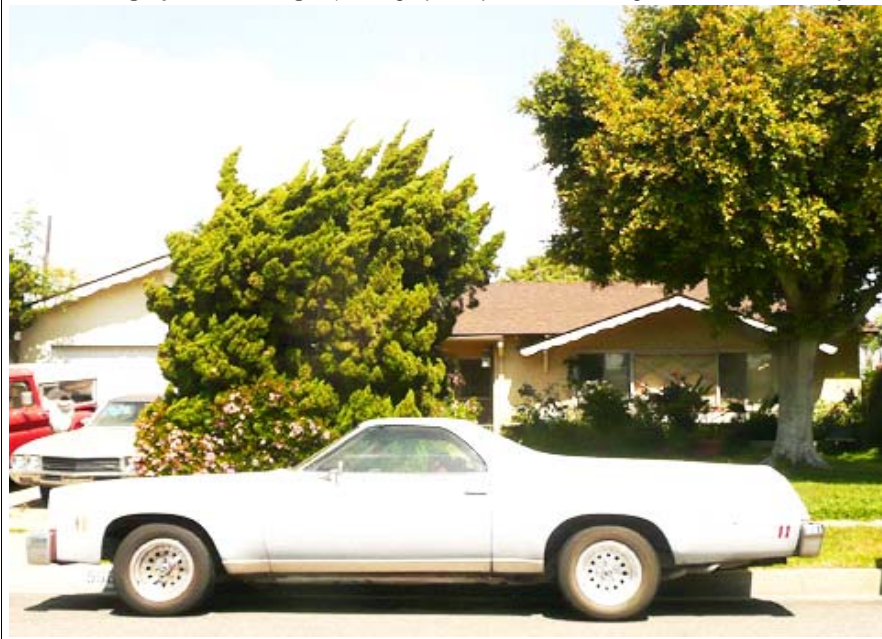
Facing southwest; 4/1/2010; Photo No.

* P3a. Description: (Describe resource and its major elements. Include design, materials, condition, alterations, size, setting, and boundaries.)
The one-story Storybook Ranch style building is 'L'-shaped in plan. The cross gabled roof is clad in composition shingles. The front facing gables are accented with scalloped barge board and brackets. The exterior walls are clad in smooth textured stucco. The aluminum sliding windows appear to be original. The paired windows on the northerly bay of the primary (northeast) façade are accented with a decorative diamond-shaped false timbering panel and wood surrounds. The primary entrance is recessed. The building does not meet the NRHP and CRHR eligibility criteria for the reasons identified on the district record prepared for this subdivision; therefore the building does not contribute to a historic district and is not individually eligible for listing in the NRHP and the CRHR.

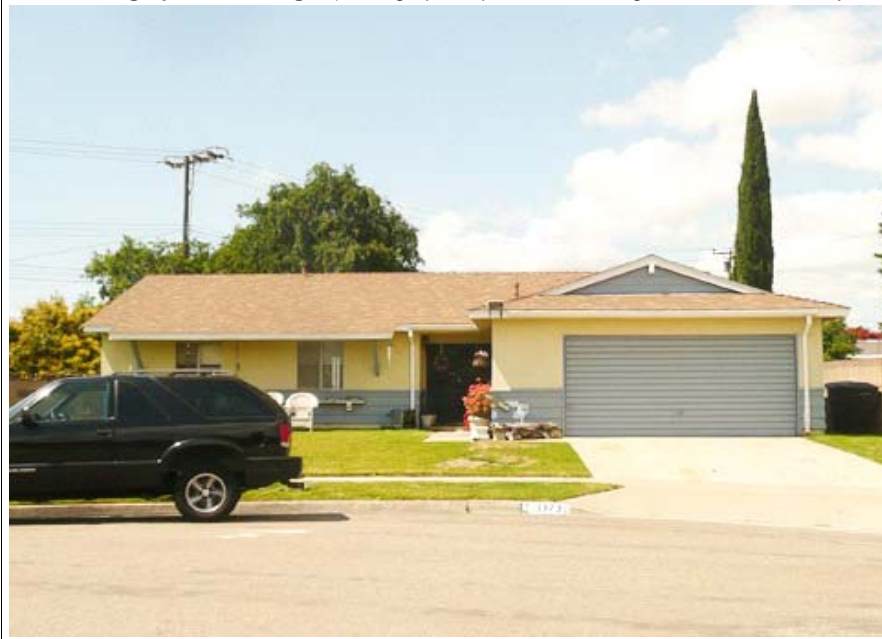
Facing north; 4/1/2010; Photo No.

* P3a. Description: (Describe resource and its major elements. Include design, materials, condition, alterations, size, setting, and boundaries.)
The one-story Ranch style building is 'L'-shaped in plan. The cross gable/gable on hip roof, with boxes eaves, is clad in composition shingles. The roof on the western bay of the primary (southern) façade overhangs and is supported by brackets. The front-facing gable is accented with horizontal wood siding and a false beam at the apex of the gable. The exterior walls are clad in smooth textured stucco with horizontal wood siding to the water line. The aluminum sliding windows appear to be original. The central window of the western bay of the primary (southern) façade is accented with a flowerbox ledge. The primary entrance is recessed and is at grade. An attached garage is located on the eastern end of the primary (southern) façade and is characterized by a pivot door. The building does not meet the NRHP and CRHR eligibility criteria for the reasons identified on the district record prepared for this subdivision; therefore the building does not contribute to a historic district and is not individually eligible for listing in the NRHP and the CRHR.

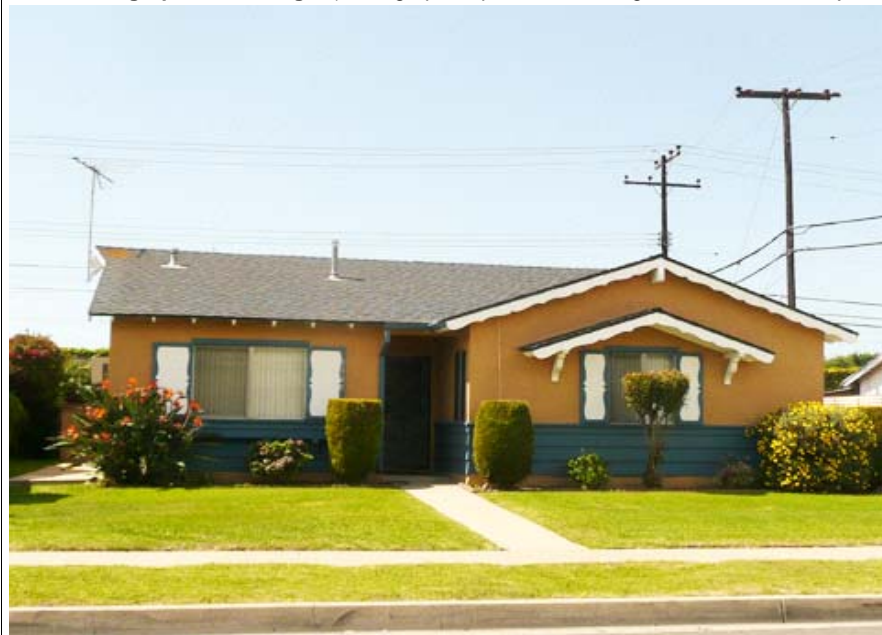
Facing southwest; 4/1/2010; Photo No.
P1040136.jpg

* P3a. Description: (Describe resource and its major elements. Include design, materials, condition, alterations, size, setting, and boundaries.)
The one-story Ranch style building is 'L'-shaped in plan. The cross gabled roof, with flared gables and boxed eaves, is clad in composition shingles. The front facing gables are accented with scalloped barge board and brackets or a false beam at the gable apex. The exterior walls are clad in smooth textured stucco with horizontal wood siding to the water line. The aluminum sliding windows appear to be original and are accented with shutters. The primary entrance is raised, recessed, and accessed via a cast concrete porch. A detached garage is located in the rear of the parcel. The building does not meet the NRHP and CRHR eligibility criteria for the reasons identified on the district record prepared for this subdivision; therefore the building does not contribute to a historic district and is not individually eligible for listing in the NRHP and the CRHR.

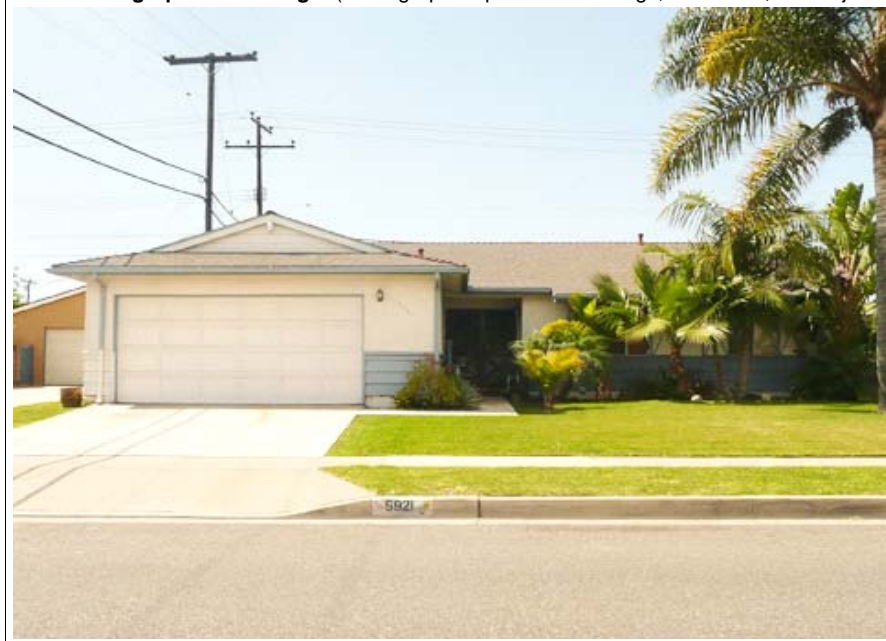
Facing southwest; 4/1/2010; Photo No.

* P3a. Description: (Describe resource and its major elements. Include design, materials, condition, alterations, size, setting, and boundaries.)
The one-story Ranch style building is 'L'-shaped in plan. The cross side gable/gable on hip roof is clad in composition shingles. The front-facing gable is accented with horizontal wood siding and a false beam at the apex of the gable. The exterior walls are clad in popcorn-textured stucco, with horizontal wood siding to the water line. The aluminum sliding windows appear to be original and are accented with shutters. The primary entrance is raised, recessed, and accessed via a cast concrete porch. The building does not meet the NRHP and CRHR eligibility criteria for the reasons identified on the district record prepared for this subdivision; therefore the building does not contribute to a historic district and is not individually eligible for listing in the NRHP and the CRHR.

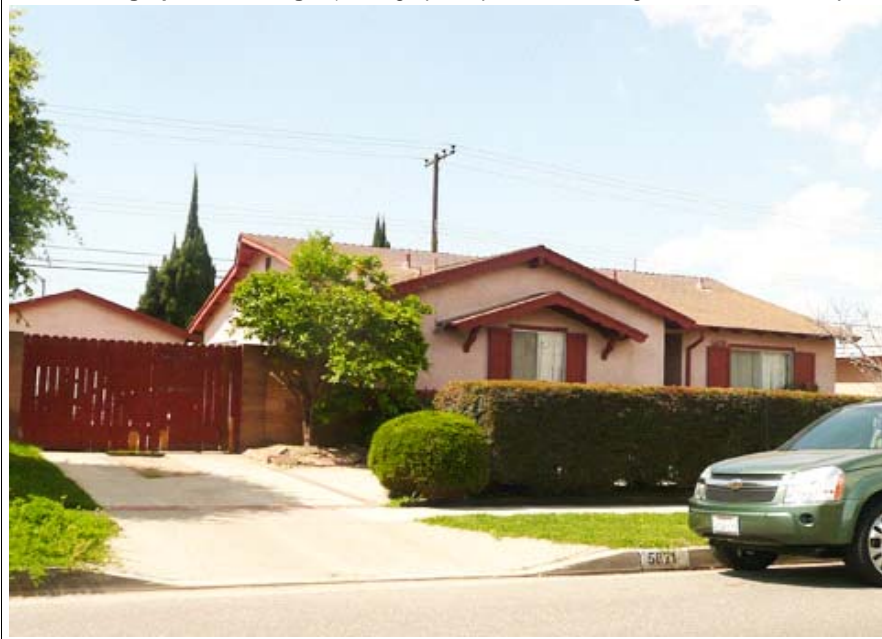
Facing southwest; 4/1/2010; Photo No.

* P3a. Description: (Describe resource and its major elements. Include design, materials, condition, alterations, size, setting, and boundaries.)
The one-story Ranch style building is 'L'-shaped in plan. The cross gabled roof, with flared gables, is clad in composition shingles. The front-facing gables are accented with scalloped barge board, and/or brackets and a false beam at the apex of the gable. The exterior walls are clad in textured stucco, with horizontal wood siding to the water line. The aluminum sliding windows appear to be original, and are accented with wood surrounds and shutters. The primary entrance is raised, and is accessed via a cast concrete porch. A detached garage is located in the rear of the parcel. The building does not meet the NRHP and CRHR eligibility criteria for the reasons identified on the district record prepared for this subdivision; therefore the building does not contribute to a historic district and is not individually eligible for listing in the NRHP and the CRHR.

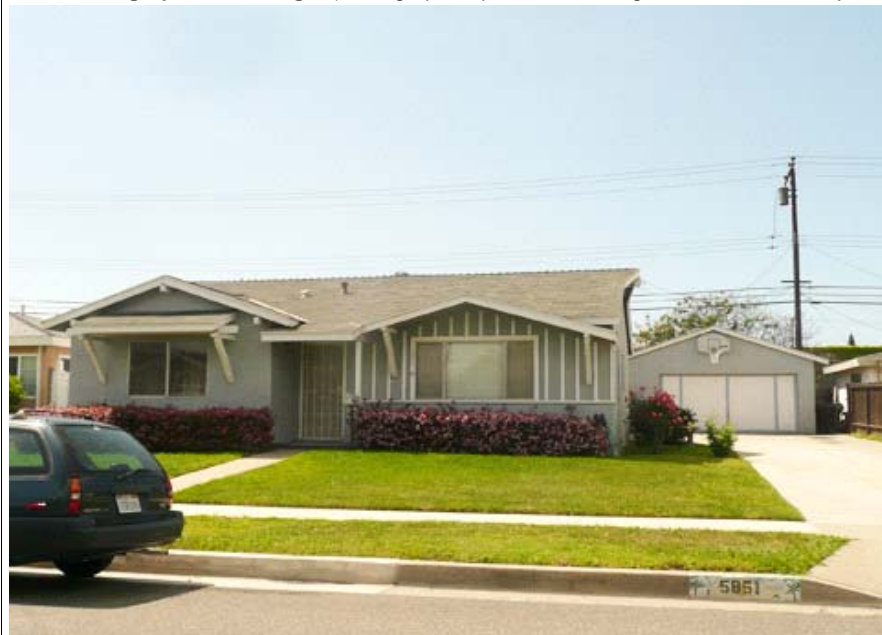
Facing southwest; 4/1/2010; Photo NO.

* P3a. Description: (Describe resource and its major elements. Include design, materials, condition, alterations, size, setting, and boundaries.)
The one-story Ranch style building is rectangular in plan. The cross gabled roof, with flared gables and boxed eaves, is clad in composition shingles. The front facing gables are accented with false beams. The northern gable is further accented with triangulated knee brackets, and the southern bay is accented with false beams in the gable. A pent roof, with boxed eaves and triangulated knee brackets, shelters the aluminum sliding window in the southerly bay. The exterior walls are clad in smooth textured stucco, and the northerly bay is accented with false timbering above the water line. The aluminum sliding and fixed-pane windows appear to be original. The primary entrance is raised, recessed, and accessed via a cast concrete porch. A square wood post supports the roof which overhangs to shelter the entryway. A detached two-car garage, with pivot door, is located in the rear of the parcel. The building does not meet the NRHP and CRHR eligibility criteria for the reasons identified on the district record prepared for this subdivision; therefore the building does not contribute to a historic district and is not individually eligible for listing in the NRHP and the CRHR.

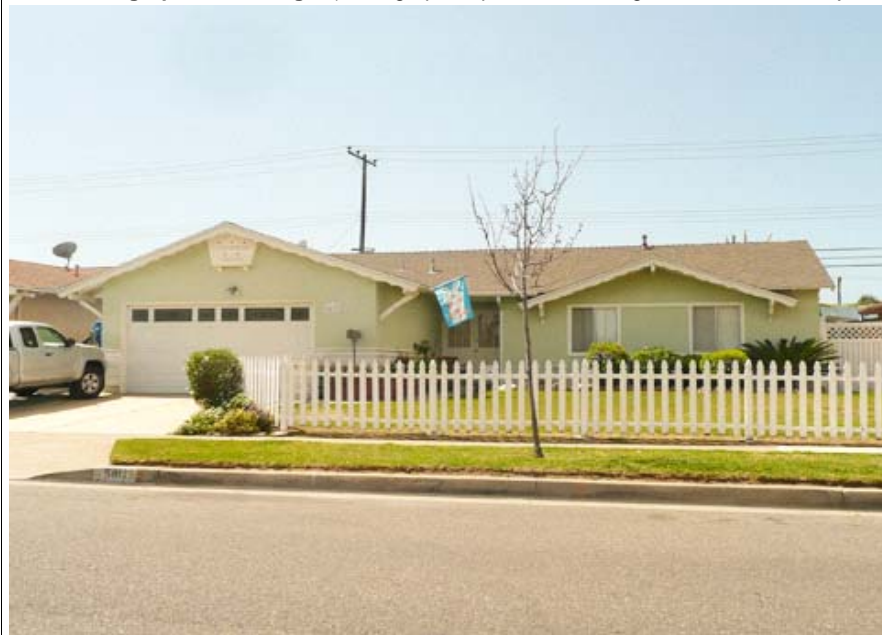
Facing southwest; 4/1/2010; Photo No.
P1040140.jpg

* P3a. Description: (Describe resource and its major elements. Include design, materials, condition, alterations, size, setting, and boundaries.)
The one-story Ranch style building is 'L'-shaped in plan. The cross gabled roof is clad in composition shingles. The front-facing gables are accented with scalloped barge board and brackets. The northerly gable is also accented with a false beam at the apex of the gable, and the southerly gable is further accented with a doveote. The exterior walls are clad in popcorn-textured stucco, and the projecting garage bay is accented with horizontal wood siding to the water line. The aluminum sliding windows appear to be original, and the paired windows located on the northerly bay of the primary (east) façade are accented with a wood surround which envelopes both windows. The primary entrance is recessed and is at grade. The building does not meet the NRHP and CRHR eligibility criteria for the reasons identified on the district record prepared for this subdivision; therefore the building does not contribute to a historic district and is not individually eligible for listing in the NRHP and the CRHR.

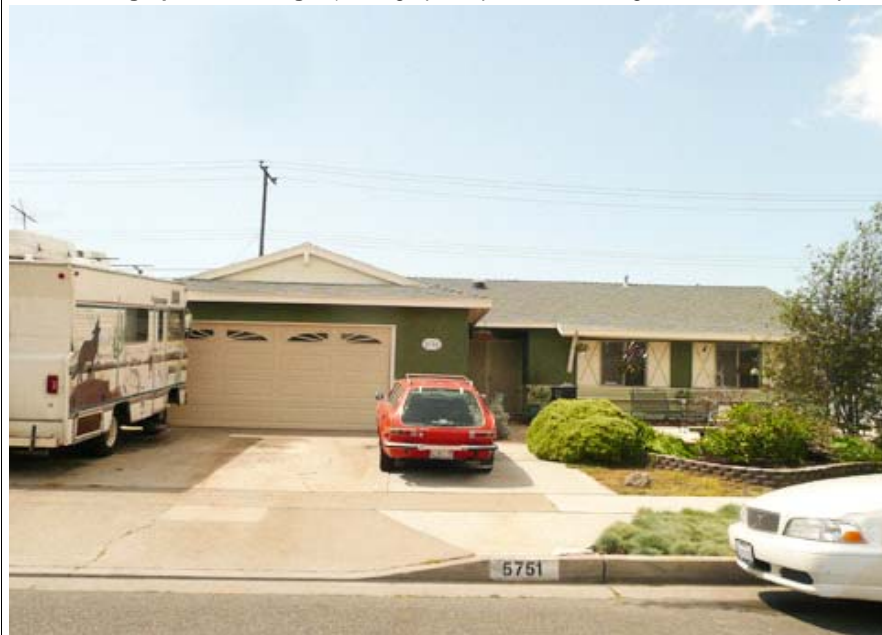
Facing southwest; 4/1/2010; Photo No.

* P3a. Description: (Describe resource and its major elements. Include design, materials, condition, alterations, size, setting, and boundaries.)
The one-story Ranch style building is 'L'-shaped in plan. The cross side gable/gable on hip roof is clad in composition shingles. The front-facing gable is accented with horizontal wood siding and a false beam at the roof apex. The roof overhangs on the northerly bay of the primary (east) façade, and is supported with brackets. The exterior walls are clad in rough textured stucco, which appears to be an alteration, and horizontal wood siding to the water line. The aluminum sliding windows appear to be original, and are accented with shutters. The primary entrance is recessed and is at grade. A patio area was constructed in the front yard at an unknown date. The building does not meet the NRHP and CRHR eligibility criteria for the reasons identified on the district record prepared for this subdivision; therefore the building does not contribute to a historic district and is not individually eligible for listing in the NRHP and the CRHR.
